# TROUBLESHOOTING

Troubleshooting Guide

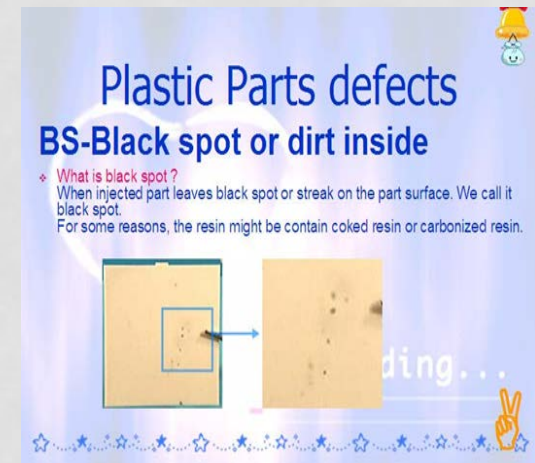
# BLACK SPOTS/SPECS

Black spots and brown streaks appear as dark spots or streaks in the molded part and are usually caused by thermal damage to the melt.

- Check the material for contamination.
- Decrease the melt temperature.
- Decrease the overall cycle time.
- Purge and/or clean the screw and barrel.
- Decrease the screw speed. High screw speeds may cause the material to degrade.
- Material may have too much regrind content.
- Material may be over dried. Decrease drying time/temperature. Refer to drying instructions provided by the material supplier.
- Material may be prone to thermal degradation. It may be necessary to use a more thermally stable material.
- Dead spots may be occurring, ensure that the alignment between the machine nozzle and mold sprue is correct.
- Residence time may be too long, or the shot size may be too small for the machine. It may be necessary to move the mold to a machine with less injection capacity.

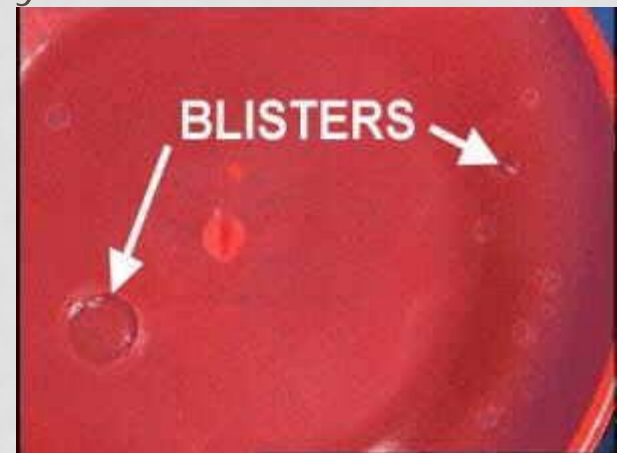
# BLISTERING/BUBBLES

- Blistering – These are bubbles or raised imperfections that are generally caused by too much heat and/or inadequate cooling

1. Trapped gas, which includes air, moisture vapor, volatiles from the resin, or decomposition gases from the polymer or additives.
2. Vacuum void.

- If it is a gas bubble, the gas will warm up and expand, raising the surface, and often will pop as the part surface softens.
- If there is no air in the bubble and it's a vacuum void instead, the bubble will collapse due to the atmospheric pressure pushing on the softened surface of the part.

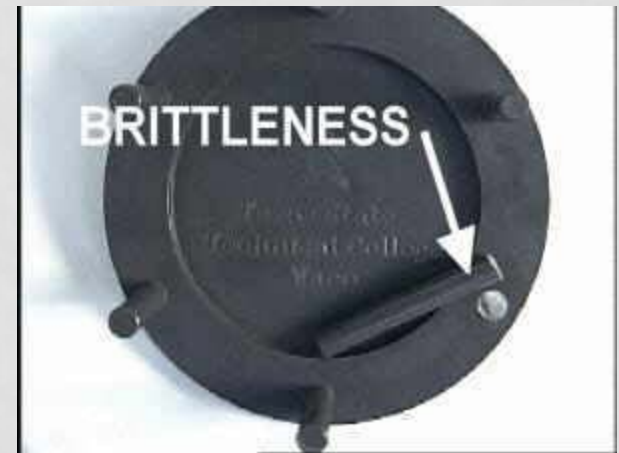
# BRITTLENESS

Brittleness is a condition where the part cracks or breaks at a much lower stress level than would normally be expected based on the virgin material properties.

- Check for material contamination.
- Decrease amount of regrind use.
- Decrease back pressure.
- Decrease injection pressure.
- Decrease screw speed.
- Increase melt temperature.
- Dry material. Refer to the drying instructions provided by the material supplier.

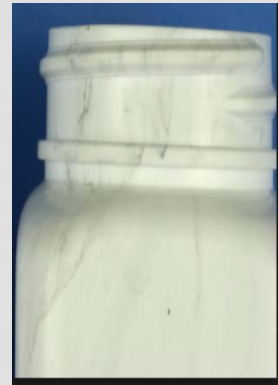
# COLD SPOTS

Sometimes, during the process of Extrusion blow molding, un melted material or cold spots appear on parisons that is also called Marbleizing. The appearance of these spots is a very serious problem that should be immediately resolved. In order to solve this, we have to know the possible causes that may lead to this problem.

- **Cause:** If the melt Temperature set is too low, it can cause cold spots in parison. Basically, due to the low temperature, melt gets cold, and resultantly Unmelt material appears in the form of clod spots.

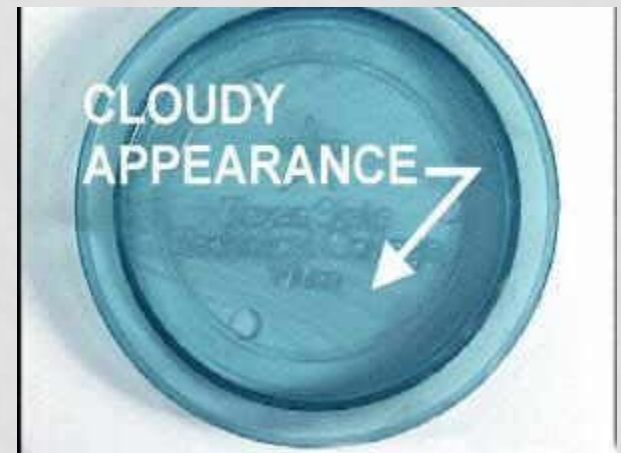
# DIM APPEARANCE OF BOTTLES

Oddly looking bottles in the whole lot can be easily identified. This happens due to the appearance of the bottle. People often get confused between marble tint and dim appearance. However, both are way different from each other. In the later one, the outer surface of the bottle becomes cloudy. This reduces the mechanical strength of the bottle too many folds. Also, makes it appear dim.

- **Cause of Defect** – There are several reasons that lead to the dim appearance of the bottle. A preform appears to be cloudy white tinted if the temperature range and cooling range goes beyond a certain level. PET container is heated up to the range of temperature that goes beyond the chilling point of 125°C. Another reason for the defect is the improper blowing of the bottle. If the bottle is kept for stabilization for a long-time due to slow speed, the tinted effect appears.
- **Remedy**– To rectify the defect, the heating temperature has to be decreased. This can be done by any of the following methods: Reduce the number of lamps or intensify the furnace ventilation. This lowers the percentage of heating area and adjusts the rate of heating to reduce the temperature of performing below the critical temperature.

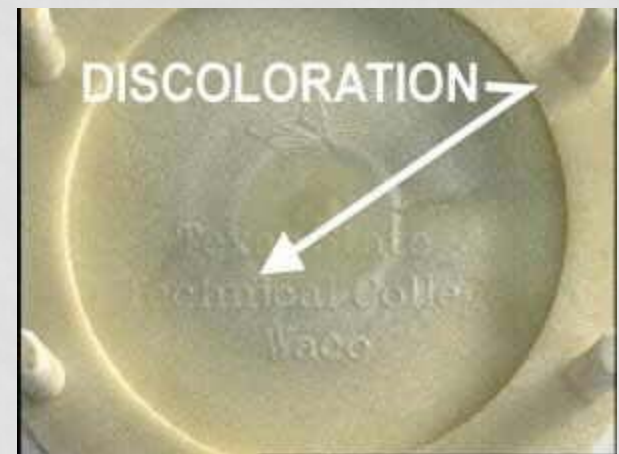
# DISCOLORATION

Discoloration – similar to burn marks or brown streaks but generally not as dark or severe. It may cause the part to be a darker shade than the virgin pellets and is often found nearest the gate area; however, it can also appear as dark streaks throughout the part.

- Check hopper and feed zone for contamination.
- Decrease back pressure.
- Decrease melt temperature.
- Decrease nozzle temperature.
- Move mold to smaller shot-size press.
- Provide additional vents in mold.
- Purge heating cylinder.
- Shorten overall cycle.

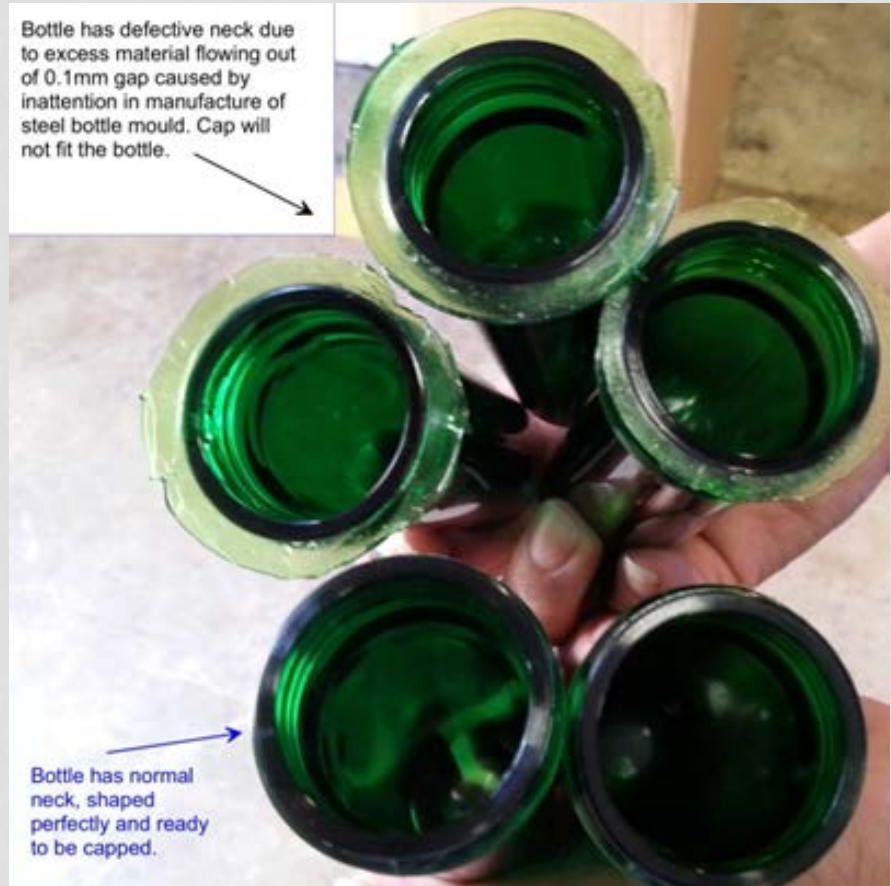
# EXCESSIVE FLASH

- Excessive flash is often seen near sealing faces, out of vent grooves, or down ejector pins. The extra plastic that breaks off on neck. It appears as thin or sometimes thick sections of plastic where it would not be on a normal part.
- Note: Flash can very quickly (within a few cycles) damage the parting line surfaces.

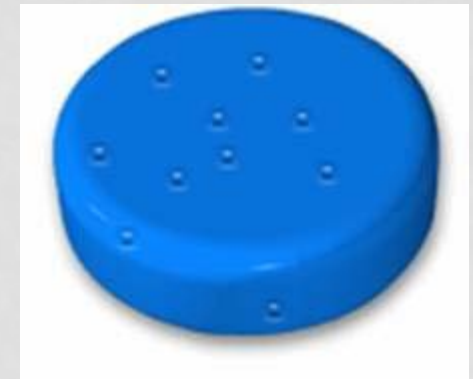
# FISH EYES

Fish eyes are a surface defect that results from unmelted material being pushed with the melt stream into the cavity and appearing on the surface of a molded part.

If the melt temperature is too low to melt the material completely, the unmelted pellets will merge with the melt stream, marring the surface of the part.

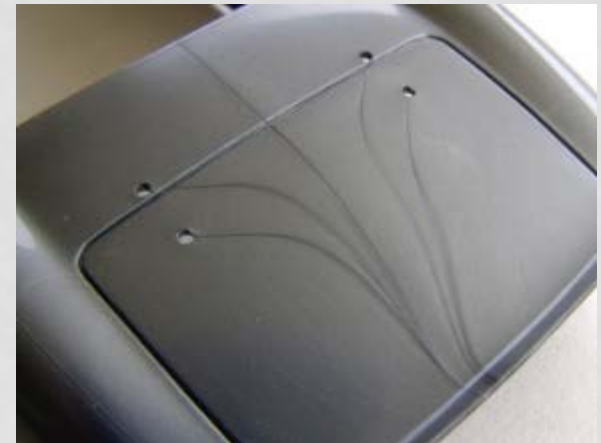
# FLOW LINES

- Description: Flow lines are streaks, patterns, or lines - commonly off-toned in color - that show up on the prototype part as a consequence of the physical path and cooling profile of the molten plastic as it flows into the injection mold tooling cavity. Injection molded plastic begins its journey through the part tooling via an entry section called a “gate.” It then flows through the tool cavity and cools (eventually hardening into a solid).
- **Causes:** Flow line defects are caused by the varying speed at which the molten plastic flows as it changes direction through the contours and bends inside the mold tool. They also occur when the plastic flows through sections with varying wall thickness, or when the injection speed is too low causing the plastic to solidify at different speeds.

- Increase injection speeds and pressure to the optimal level, which will ensure the cavities are filled properly (while not allowing the molten plastic time to start cooling in the wrong spot). The temperature of the molten plastic or the mold itself can also be elevated to ensure the plastic does not cool down sufficiently to cause the defect.
- Round corners and locations where the wall thickness changes to avoid sudden changes in direction and flow rate.
- Locate the gate at a spot in the tool cavity with thin walls.

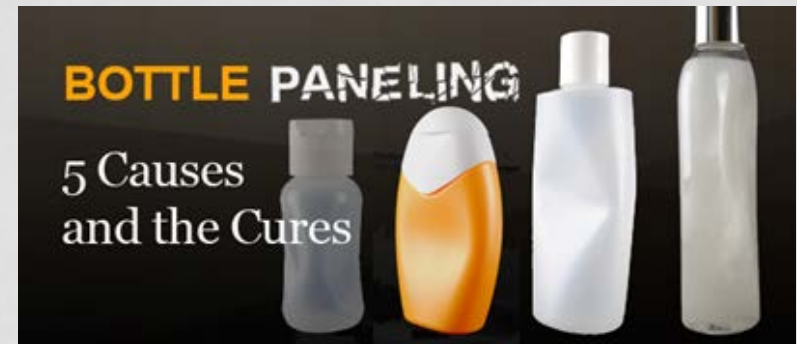
# PANELING

- Paneling occurs when the pressure inside a plastic bottle becomes less than the ambient air pressure outside, causing the walls of the bottle to partially collapse inward.
- The result is an aesthetically unappealing product package with a distorted shape and badly puckered or wrinkled labels.
- Research has shown that a consumer's first reaction to a bottle affected by paneling is often, "there must be something wrong with it," potentially leading to a loss of business and damage to the brand.
- Fortunately, the causes of paneling are easy to identify and just as easy to avoid.

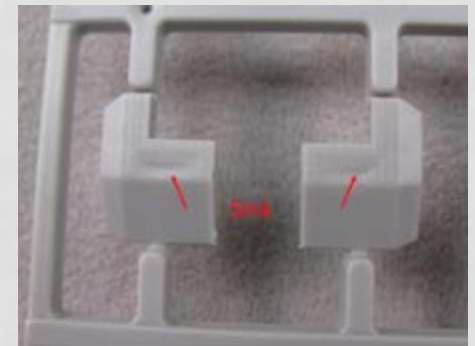
# SINK MARKS

- Description: Sink marks are small craters or depressions that develop in thicker areas of the injection molded prototype when shrinkage occurs in the inner portions of the finished product. The effect is somewhat similar to sinkholes in topography, but caused by shrinkage rather than erosion.
- **Causes:** Sink marks are often caused when the cooling time or the cooling mechanism is insufficient for the plastic to fully cool and cure while in the mold. They can also be caused by inadequate pressure in the cavity, or by an excessive temperature at the gate. All else being equal, thick sections of the injection molded part take longer to cool than thin ones and so are more likely to be where sink marks are located.

- Mold temperatures should be lowered, holding pressure increased, and holding time prolonged to allow for more adequate cooling and curing.
- Reducing the thickness of the thickest wall sections will also ensure faster cooling and help reduce the likelihood of sink marks.

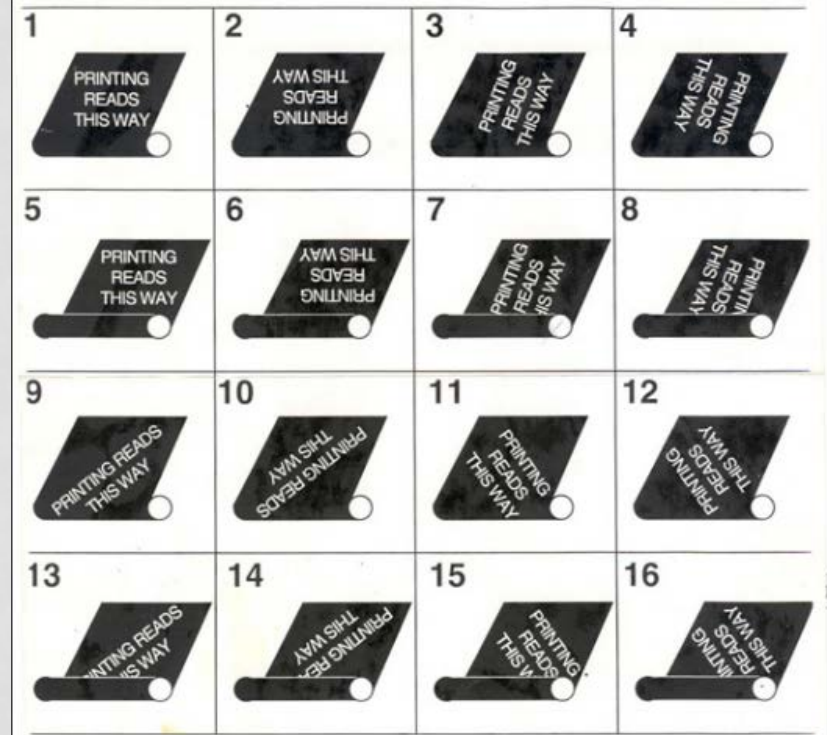
## STANDARD UNWIND ROLL CHART

The [unwind direction](#) is important when applying labels. So if you are working with a co-packer, communicate their unwind needs before the label makes it to press. Regardless of if it is a product of flexographic label printing or digital label printing, this is an important step in the process.
